University of Minnesota Landscape Arboretum Runoff Model

Sarah Elliott and Mary H. Meyer, Department of Horticultural Science

Minnesota Landscape Arboretum Runoff Model. 2003

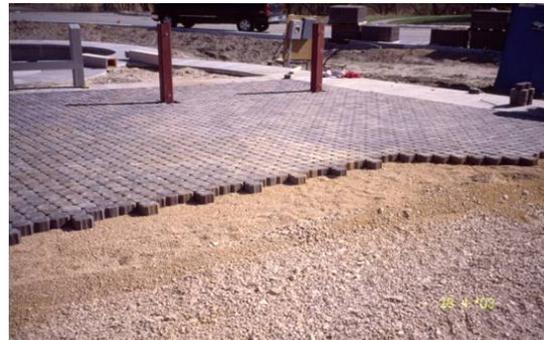
Installation of permeable paving for watershed 1.

Prior to installation of the permeable paving, infiltration tests were conducted to obtain

measurements of how much water the soil can absorb in a given amount of time. Two base layers of limestone were then installed. The first was 9" thick and consisted of 1 1/2" chunks. The top layer was 3" thick and consisted of 3/4" chunks. Finally a 1" thick layer of 3/8" limestone chips was laid in such a way to provide a uniform surface for the permeable paving installation. Once the paving was in place, the voids were filled with 3/8" limestone chips. Two planting areas one filled with daylilies, the other with trees and shrubs, are located at each end of this watershed, allowing for increased infiltration.

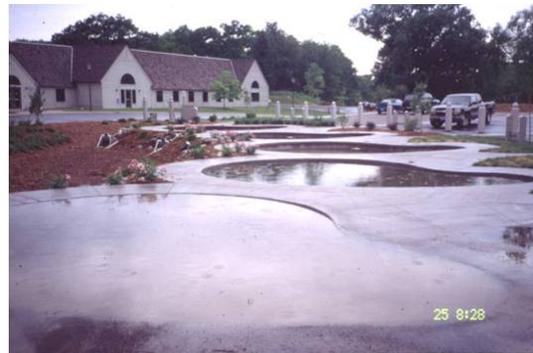
Watershed pool 5, the impervious model, is located in the foreground of this picture. The overflowing pool has the largest amount of water compared to the other pools. In the background another pool can be observed to be near capacity, but not overflowing. Pool 5 always shows the greatest increase in water level, while pool 1 shows the least. Typically, pool 1 only rises by the amount of rain that falls, since there is almost no runoff for watershed 1. As you move on to the other pools, more water accumulation can be observed due to reduced permeability of the watersheds.

Watershed 5 represents the maximum amount of impermeable paving. It lacks the presence of any vegetation and shows the poorest environmental design. This collection pool can easily overflow with rainfall events, since very little water will infiltrate into this watershed and the majority will flow from the site.

To illustrate the differences in runoff, when a 1.65" inch rainfall event occurred in July 2003, these were the amounts of rainfall found in the collection pools:

Watershed 1	2.2 inches
Watershed 2	3.1 inches
Watershed 3	7.3 inches
Watershed 4	10.2 inches
Watershed 5	above 12 inches and overflowing
